Wilsons Beach Erosion Management Strategy

Options Assessment Report

Whitsunday Regional Council

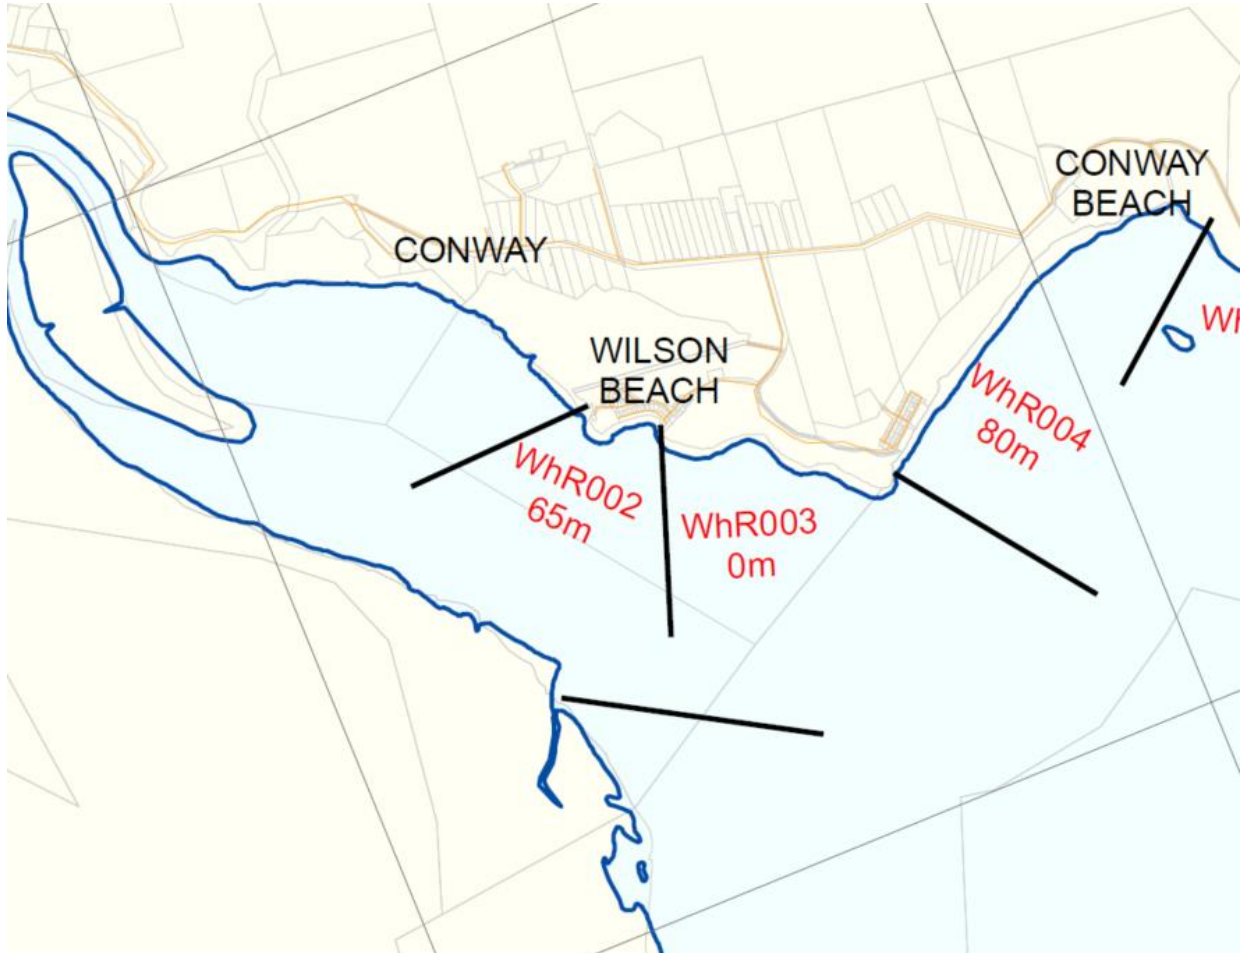
The erosion prone width (as nominated by the Department of Environment and Heritage Protection) is some 65m (Figure 8). This includes long-term erosion (previously observed and as a result of climate change) as well as potential for short-term storm erosion.

Erosion to this extent would extend beyond the property boundaries of beachfront homes at Wilsons Beach and has the potential to cause significant damage and loss to infrastructure.

Figure 8: Erosion Prone Area (Sourced: EHP)

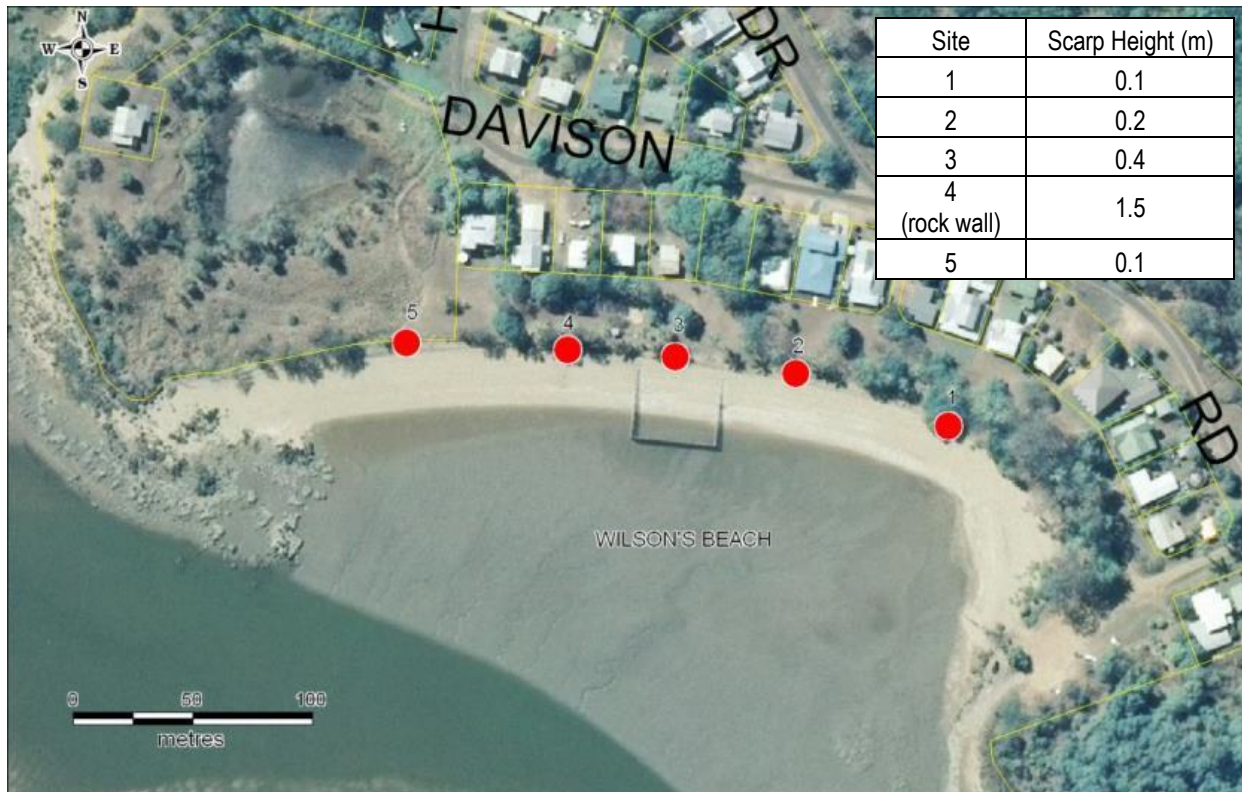
Erosion has been observed more recently in response to storm events. On the 20th February 2014, the erosion damage at Wilson's Beach was investigated. Scarp heights along Wilson's beach typically varied between 0.1 to 0.4m with heights up to 1.5m adjacent to the rock wall (Figure 9). Reported storm cut (by residents) was of the order of 5m.

Figure 9: Scarp Heights along Wilson's Beach [WRC, Feb 2014]

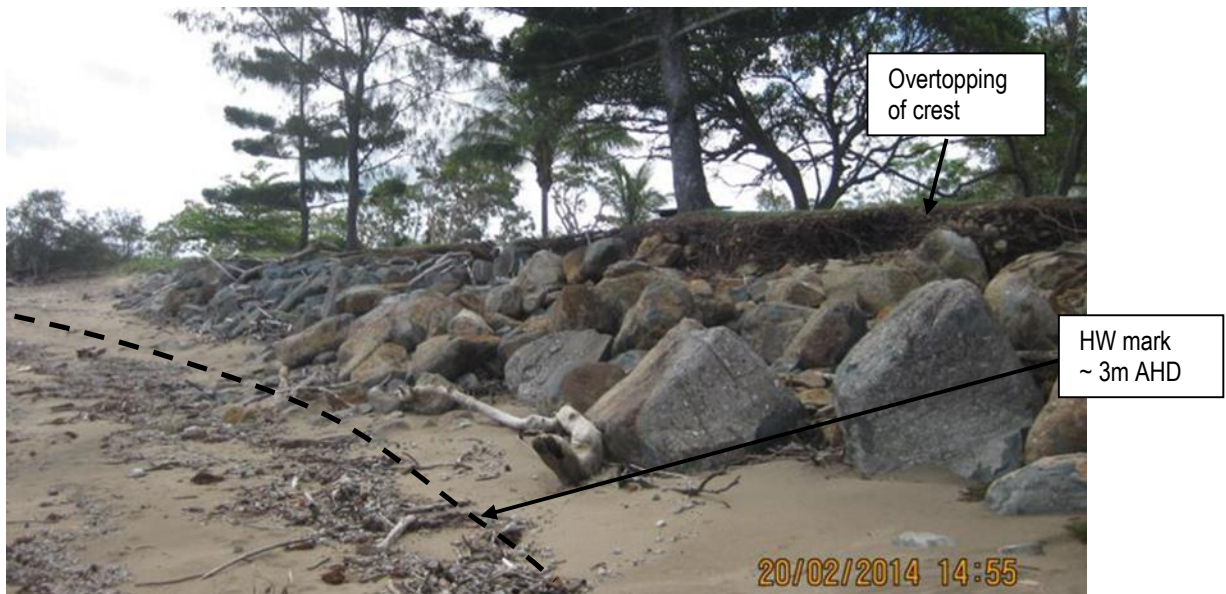
Figure 11: Seawall after Cyclone Dylan

The existing placed rock has been reasonably effective in limiting storm cut although it was overtopped and damaged during the 2014 events.

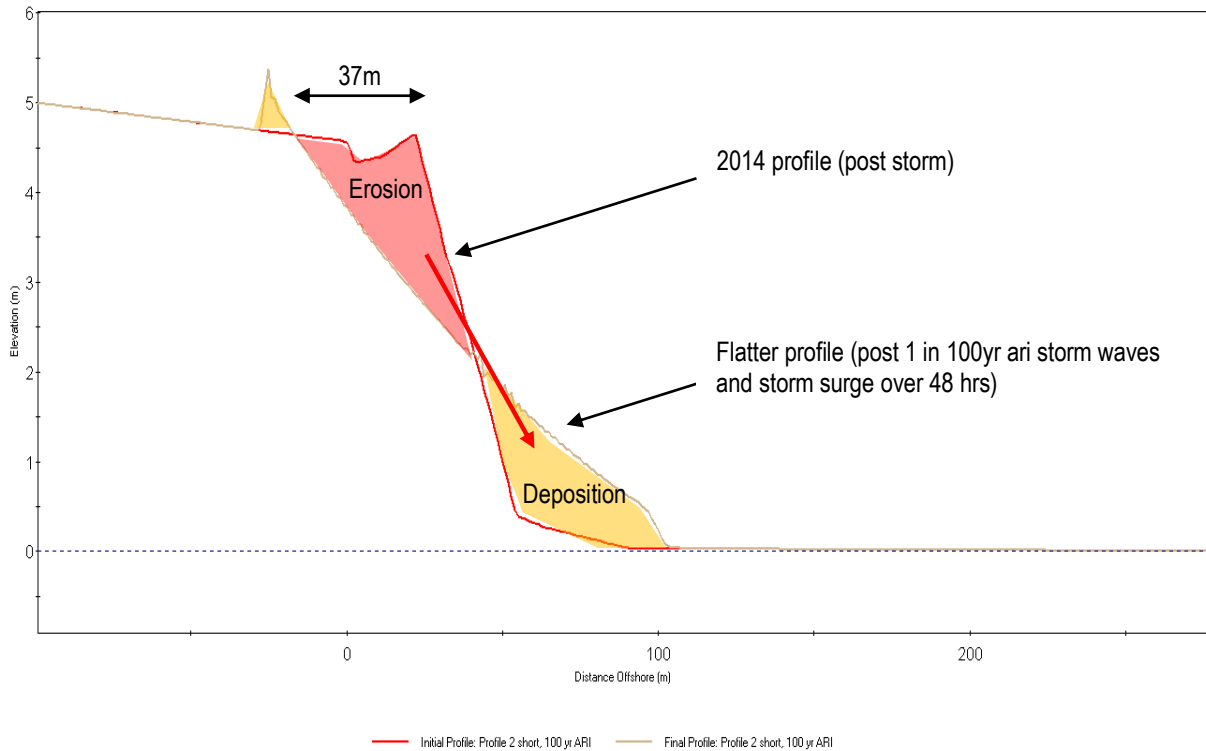
An assessment of potential storm cut has been undertaken using SBEACH modelling. It should be noted that these models have not been able to be calibrated or validated for the site given the lack of data available. Data required to calibrate and validate the SBEACH modelling would include the measured terrestrial and bathymetric survey before and after a known weather event as well as recorded data of the event itself (where data is not available locally, regional modelling may be required to determine conditions experienced at the site during the event).

Modelling clearly shows that storm tides result in variable exposure of the seawall over the course of the storm, but during periods of peak storm tide the low-lying sections of the park can experience significant inundation (Figure 10) which is consistent with overtopping of the wall experienced during 2014 storm events (Figure 11). Without protection, modelling indicates that storm cut can be substantial (Figure 12), potentially extending through the park and into private property. The beach sand is expected to largely remain in the nearshore system above low tide.

Figure 12: Uncalibrated SBeach Storm Cut 100 year ARI storm (2004)

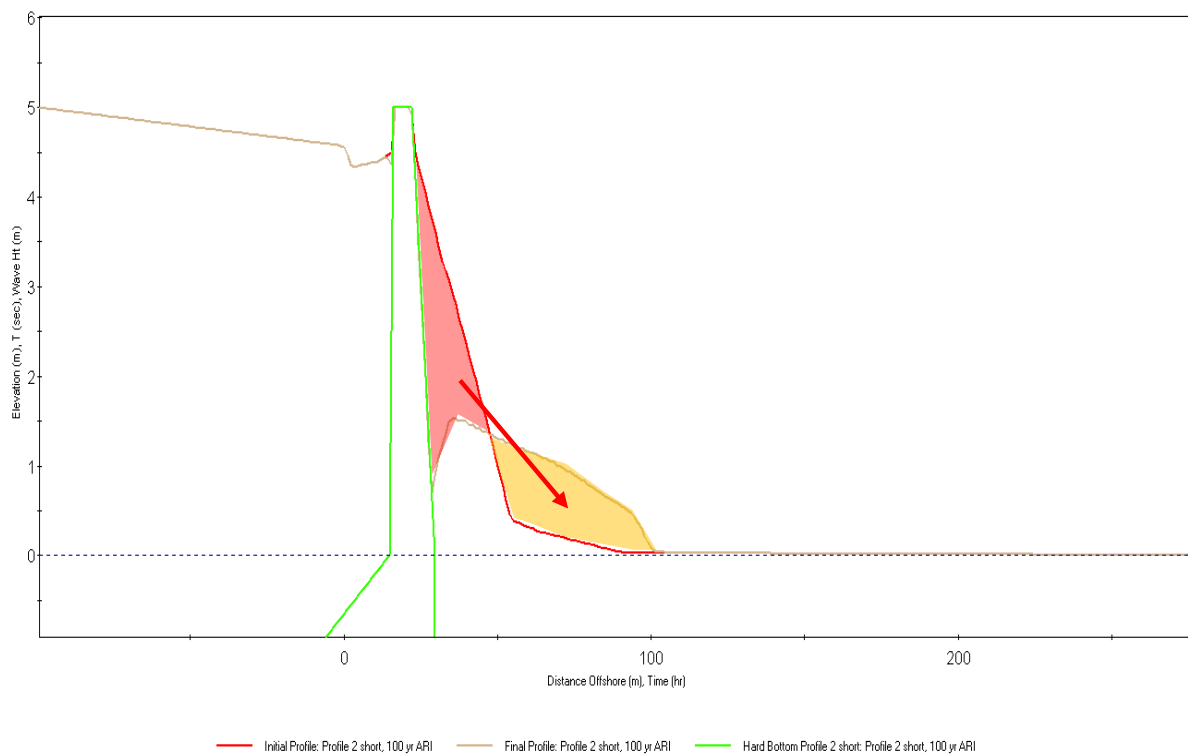
The construction of a seawall (assumed crest RL 5.2m AHD) would prevent storm cut but would result in deeper scour at the toe (Figure 13). It is shown that for a 48 hour storm event the beach could erode down to a level of +1.5m AHD, with a local scour hole in front of the seawall to approximately +0.5m AHD.

Figure 13: Uncalibrated SBeach Storm Cut 100 year ARI storm with seawall (2004)

The toe depth will depend on the selected alignment. For a wall along the present alignment, the beach level scours to +1.5m AHD with an additional local scour adjacent to the structure. Experience with other structures suggests that where local scour holes form they are typically only present during the event and in many cases flexible structures can accommodate a small amount of undermining on this basis. As such, for an alignment along the present scarp alignment a toe depth of +1.5m has been adopted. Every 10m landward raises the required toe level by about 0.5 – 0.75m and reduces the impact on beach amenity and coastal processes. The present rock wall could be removed and relocated landward but this would mean loss of mature trees. For costing comparison, it has been assumed that an alignment at least 10m landward of the current scarp will be adopted, allowing the toe level to be raised to approximately +2.25m AHD (subject to detailed design). Over time, in response to climate change, adaptation of the structure (including installation of a flexible toe) would likely be required to address increased scour.

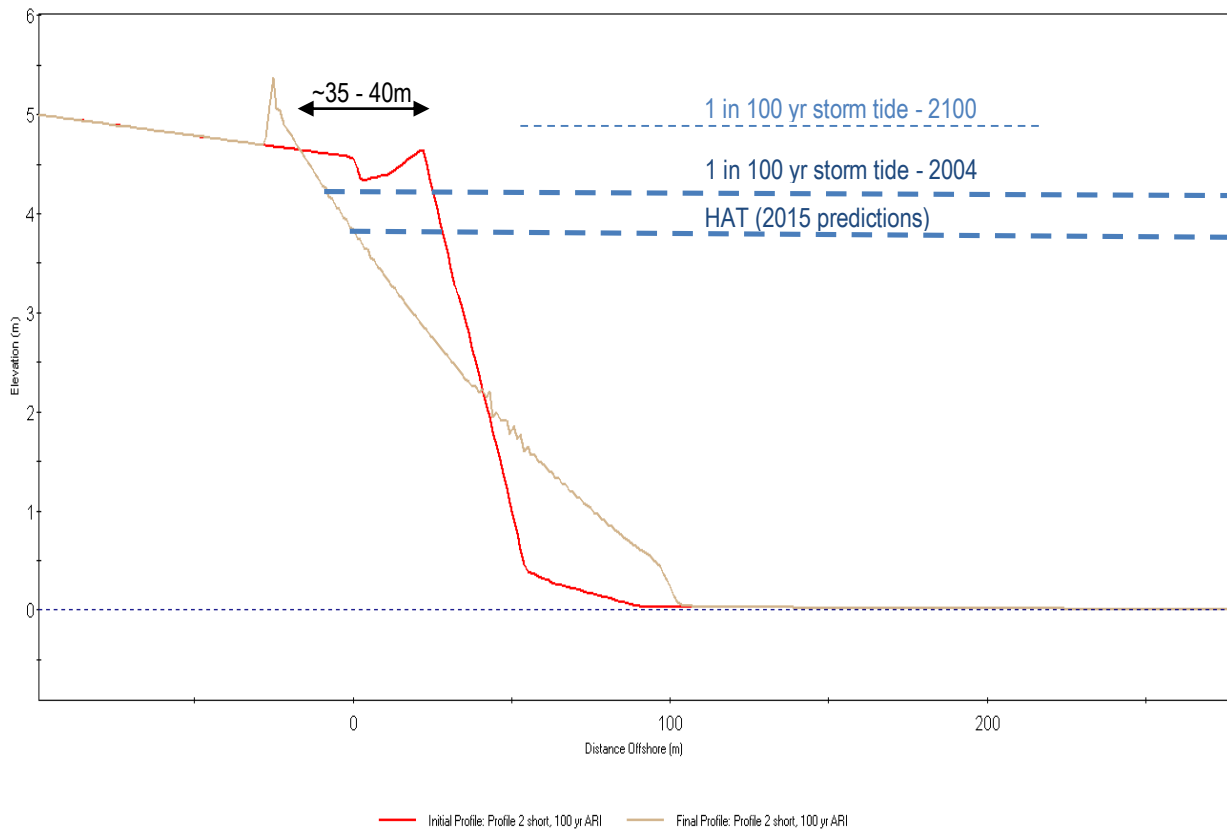
Preliminary modelling (Figure 14) shows that significant inundation and storm cut can be expected if no works are undertaken.

Figure 14: Storm cut for do nothing option (100yr ARI in 2004)

- Erosion and inundation of the developed low back dune areas will continue to occur during severe events and cause damage to vulnerable infrastructure including private properties.

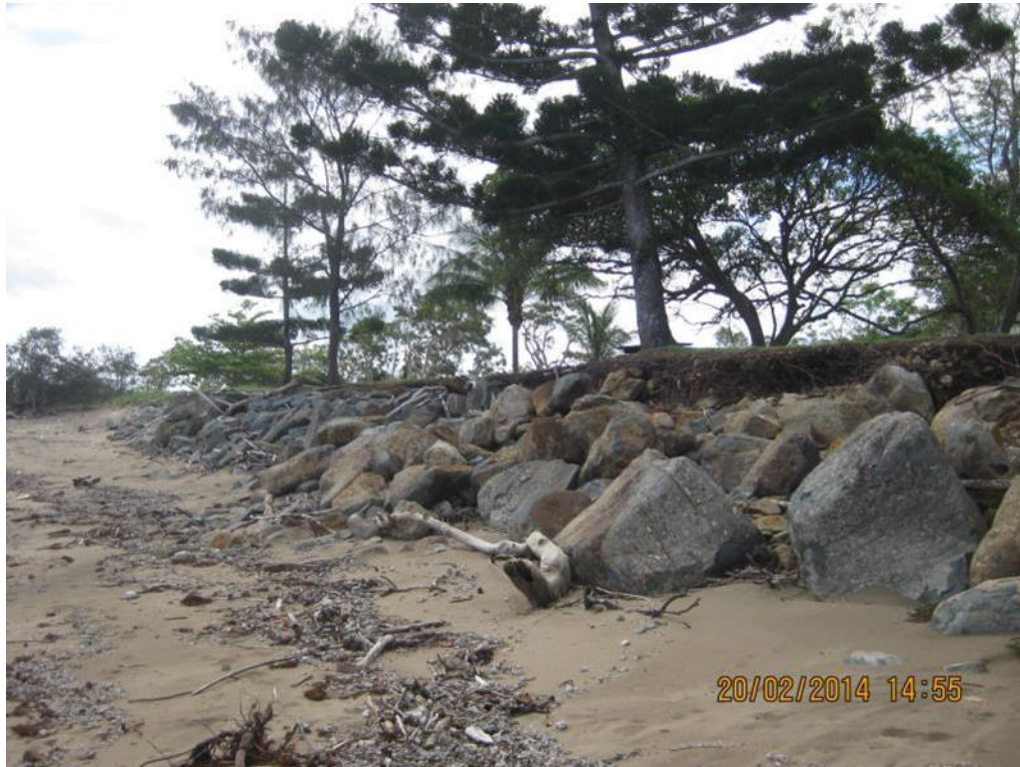
Figure 17: Present boulder wall at Wilsons Beach (overtopping damage evident)

Face stability	Flexible structure. In large events where toe scour occurs, there can be displacement of boulders and reshaping of the face. Need for rock top-up/maintenance.

Response to scour	Accommodated by slumping of rock. Need for rock top-up/maintenance.
Durability	Rock quality is a potential issue. Isn't regularly exposed to wave action, so expected lifetime is significant, with maintenance.
Constructability	Achievable during good and poor beach/weather conditions.
Maintenance	Placement of additional rock can be undertaken from top provided good access. Can be adaptable to changing conditions. i.e. climate change.
Impact on foreshore	Wave dissipation in voids results in lower reflection than other structures
Access	Needs to be provided separately (i.e. stairs over rock)
Safety	Known issues associated with voids and unstable rocks, partially mitigated through post-storm maintenance.
Visual impact	High impact although considered to blend with natural rocky headlands- , limited to periods when exposed.

Suitability: It is considered advantageous to construct the seawall landward of the scarp to protect residences against short-term erosion threats (and reestablish the dune in front of the seawall to maximize amenity).
