Strategies to Enable Mitigation to Reduce Loss and Quicken Community Recovery for Small Business in the Whitsunday Regional Council area

Report: TS1240
September, 2021

Cyclone Testing Station
College of Science and Engineering
James Cook University
Queensland, 4811, Australia

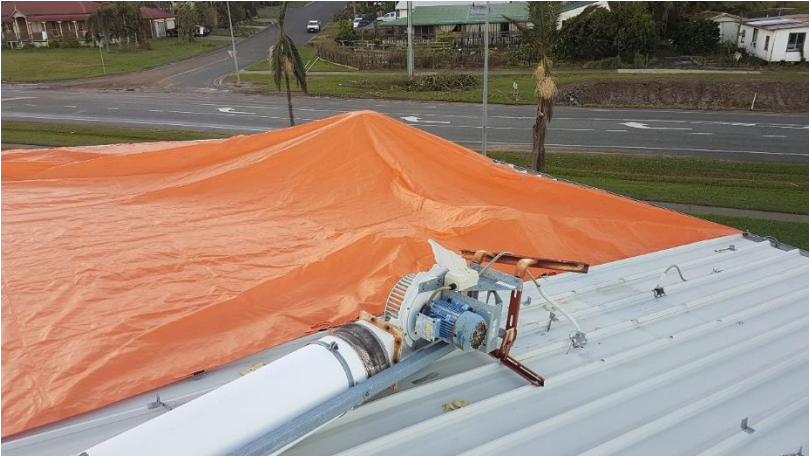
Figure B1: Failed roof vent and damage to interior

Water entry via roof vents was noted in the interviews for some business operators. Failure of roof attachments (e.g. vents, air conditioner units, flashings etc.) have been documented in all damage surveys. Improvements to design and installation of these elements were greatly updated in 2018 in revisions to building standards. An example of a failed roof mounted vent which led to internal

water damage to the building is shown in Figure B1. The replacement vent with robust connections is shown in Figure B2.

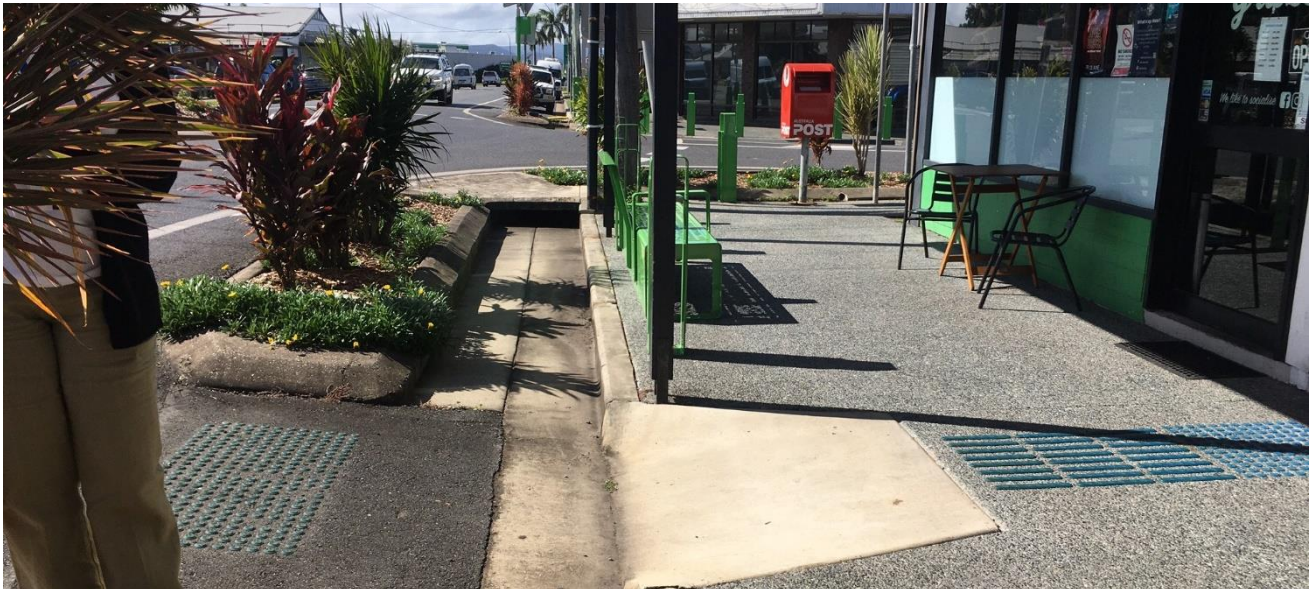
Figure B3: Height of road and drains relative to floor level of building

Water inundation from under doorways was noted by some of the interviewees. Damage was to flooring, skirting boards etc., and in some cases also required checking of electrical systems. Examples of water ingress came from (a) drains on property (e.g. in front of doors or adjacent to building below downpipes) not having enough capacity to take the water and/or having some blockage, and (b) from inundation from storm water from roadway entering via doorway. As part of the pre-storm season checklist is to check gutters, drains, etc. to be clear of obstructions, however

as noted by some interviewees this was not undertaken by them or the landlords. A useful check for potential rain runoff from road reserve is to observe how far the door sill (floor level) is above the crown of the road. Figure B3 shows the road being of similar elevation to that of the buildings floor. A mitigation measure that can be employed is to use plastic sheet and sandbagging lines across the front of the doors. QFES has details on effective sandbagging methods:
