Whitsunday Landslide Study

Landslide Susceptibility
Investigation and Mapping

M30261

Prepared for
Whitsunday Regional Council

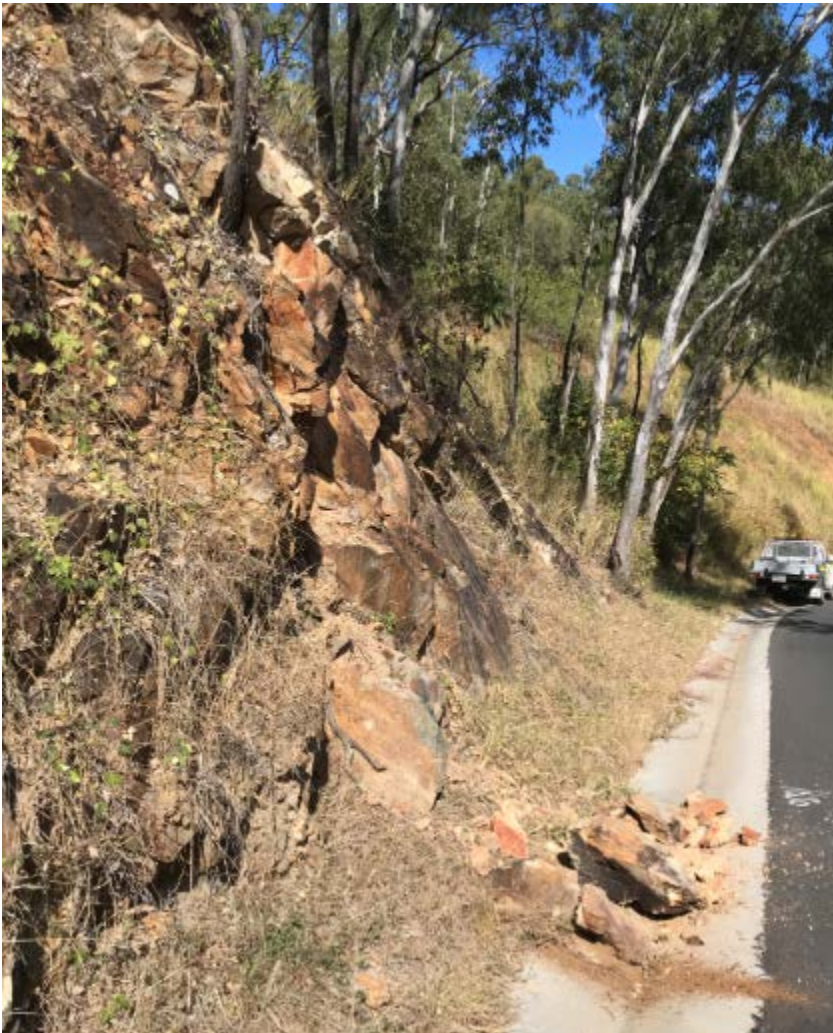
Falls: generally in rock, the natural downward motion of a detached block or series of blocks involving free falling, bouncing, rolling and sliding.

Figure 5-1 Small rock fall promoted by adverse dip and rootjacking by trees

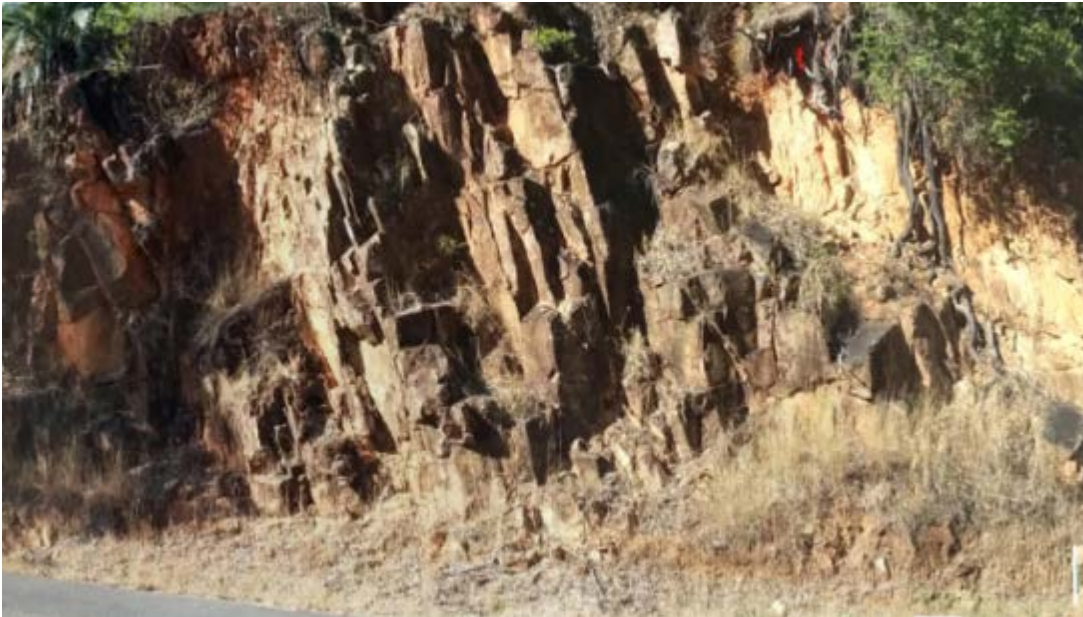
Topple: failures involving the forward rotation and movement of a mass of rock, earth or debris out of a slope.

Figure 5-2 Adverse dip and jointing in a rock cutting promoting the formation of toppling failure

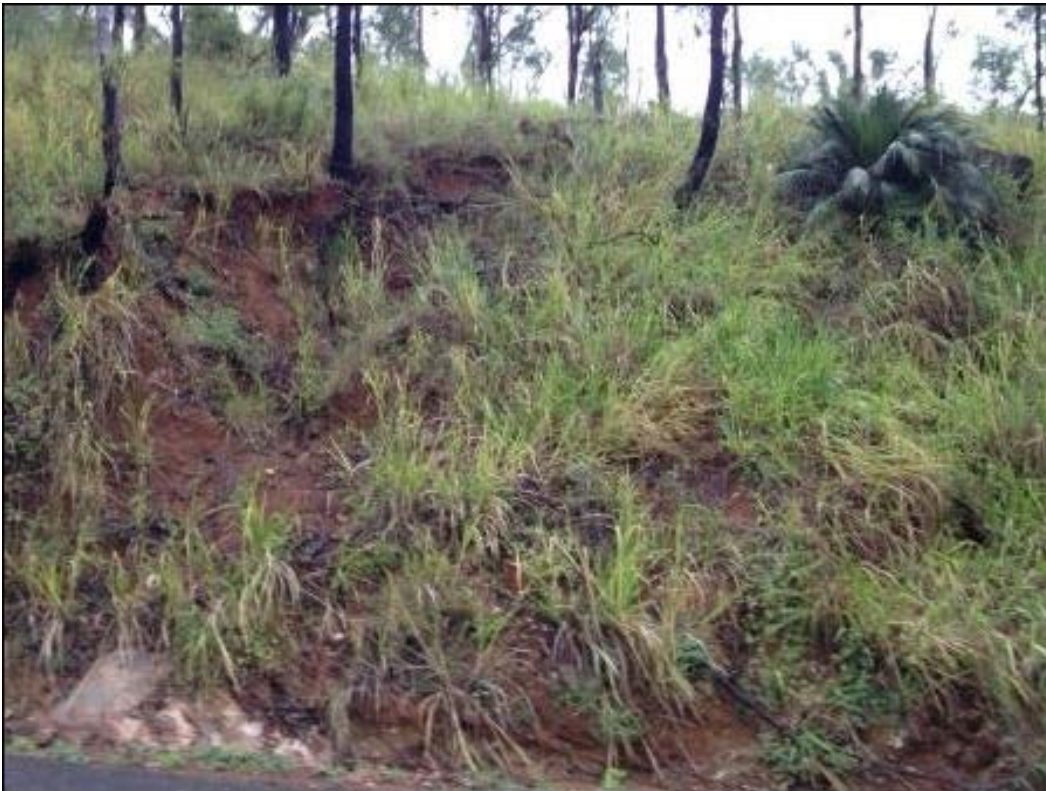
Rotational: a slide-type landslide along a distinctive curved surface. The slip surface of rotational slides tend to be deep, blocks of failed material can rotate as they fail and can sometimes be seen to tilt backwards into the slope.

Figure 5-3 Small rotational landslide in thick soils

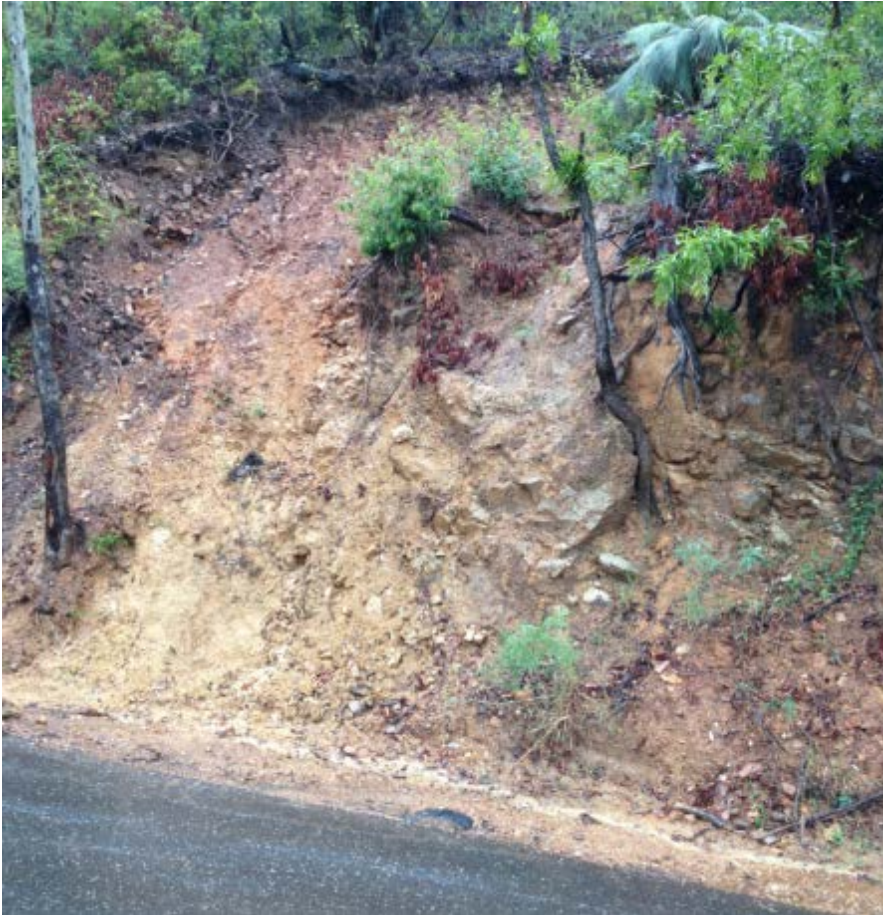
Translational: a slide-type landslide that occurs along a distinct planar surface such as a fault, joint or bedding plane. This type is common where a layer of weak soils or weathered material overlies stronger bedrock.

Figure 5-4 Translational landslide removing weaker soils over stronger bedrock

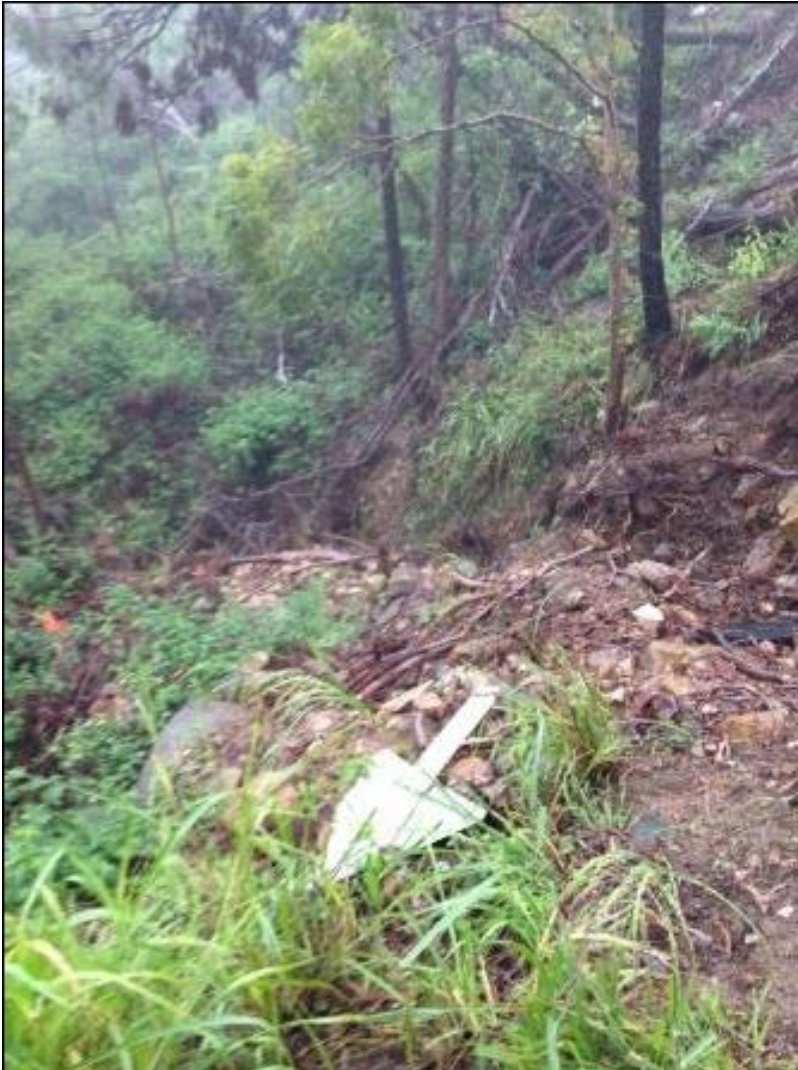
An additional landslide type has been incorporated into this report: gully slides are considered to be a combination of translational and flow slides, caused by the concentration of water into defined drainage pathways.

Figure 5-5 Small gully landslide; fluidised material caused by concentration of water flow

The largest number of landslides identified were associated with gullies; either directly as a result of erosion and failure of choked gullies, or as the result of gully erosion undermining material up the slope and causing failure. These gullies also show the longest runout distances, most likely due to fluidisation of the debris.
